Mercury Switch Removal Procedures

From Vehicle Hood and Trunk Lights

Spring 2002

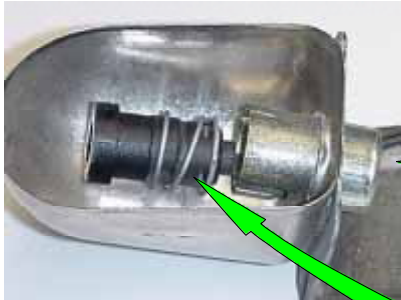
2. Remove the clip that secures the mercury switch holder in the lighting assembly by pulling the clip off with a pair of needle nose pliers

3. Remove the mercury switch holder by pushing it from the wire end into the dome reflector

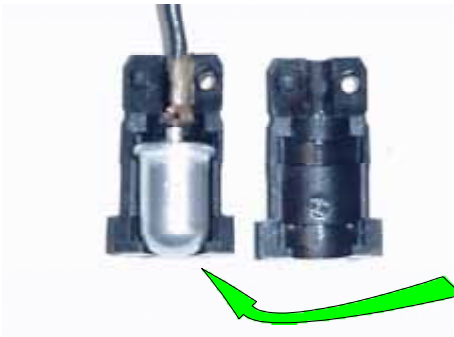
4. Remove the spring from switch holder by sliding it off

5. Pry the plastic switch holder apart along the center line using a screwdriver and replace the mercury switch with a ball-bearing switch, oriented with the rounded end toward the flanged end of the plastic holder.

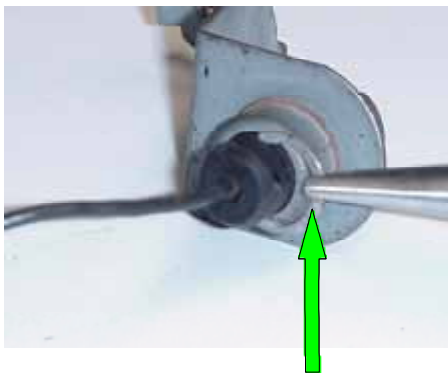
3. Remove the bulb from the assembly by pressing down and twisting counterclockwise

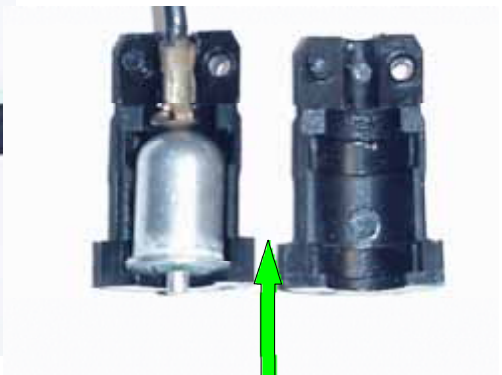
6. Remove the spring from the switch holder by sliding it off

7. Pry the plastic switch holder apart along the center line using a screwdriver and replace the mercury switch with a ball-bearing switch oriented with the rounded end toward the wire contact of the plastic holder.

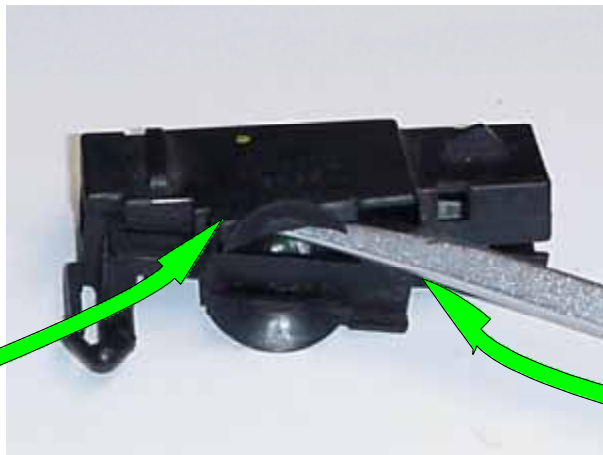
6. Move screwdriver to position shown and apply upward motion to pop front latching leg out

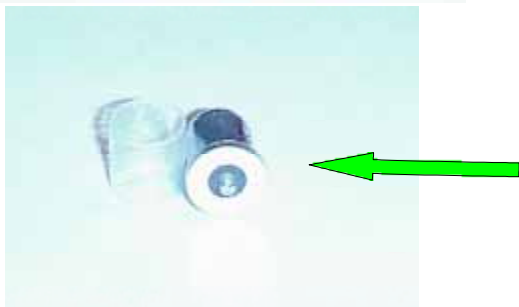
4. Use a drill with a 3/8" bit to remove the head of the pop-rievet that secures the two halves of the assembly.

5. Pry the plastic casing apart using a straight blade screwdriver and remove the mercury switch
